# Possible Effects of the Cascadia Earthquake On Clallam County

by  
Jim Buck

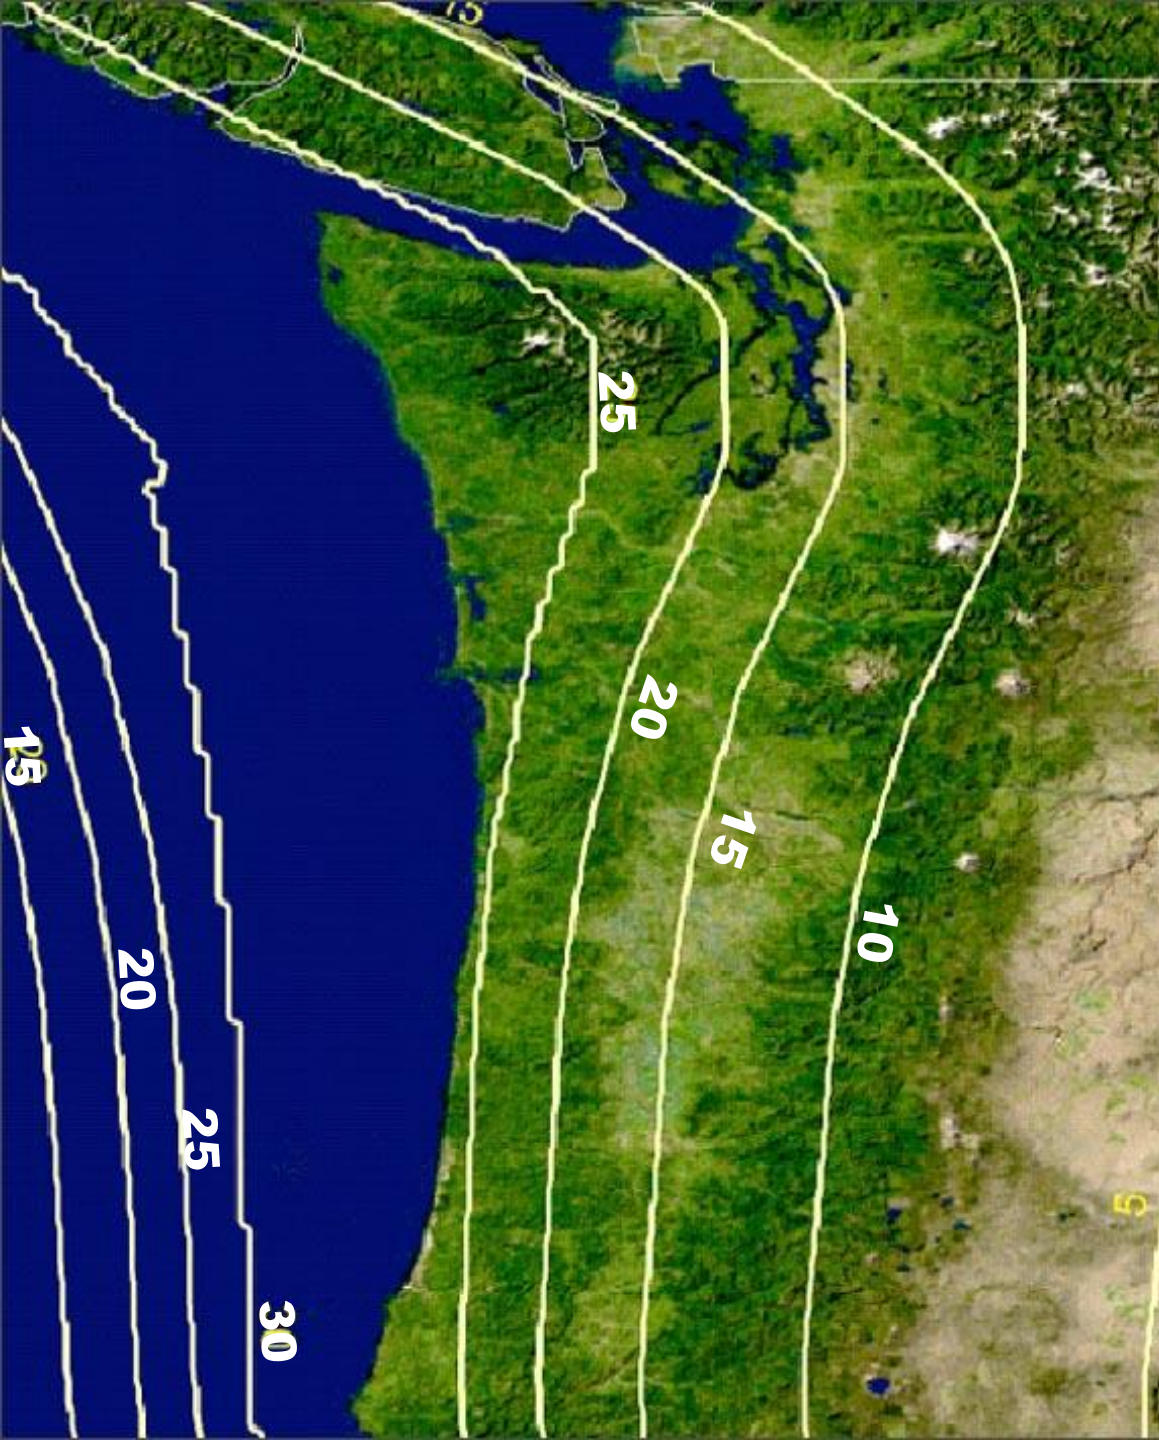
**This map shows Peak Ground Accelerations (PGAs). PGA is one measure of the strength of shaking. Higher PGAs generally result in more damage. Because this map shows average expected PGAs in an area, specific locations may have higher or lower PGAs, and significantly more or less damage. Site conditions such as soil and building type will affect the type and amount of damage at any given place.**

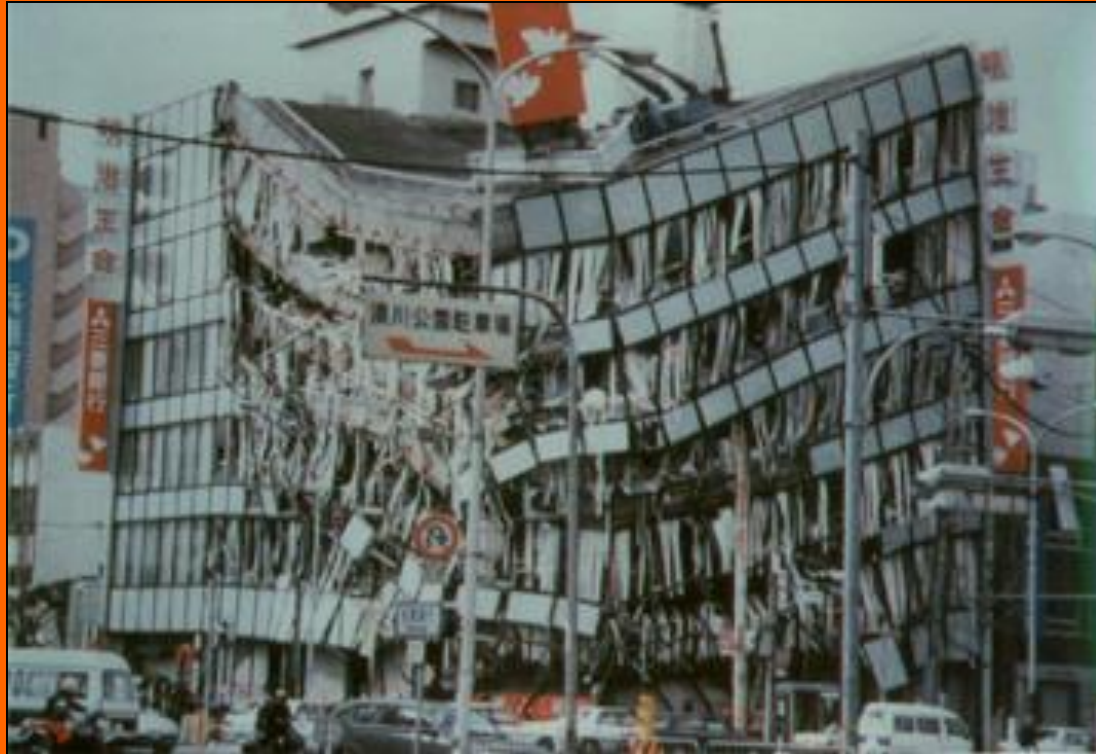
# Kobe footage

**The picture shows a six story structural steel office building with a partial failure of the foundation due to liquefaction.**

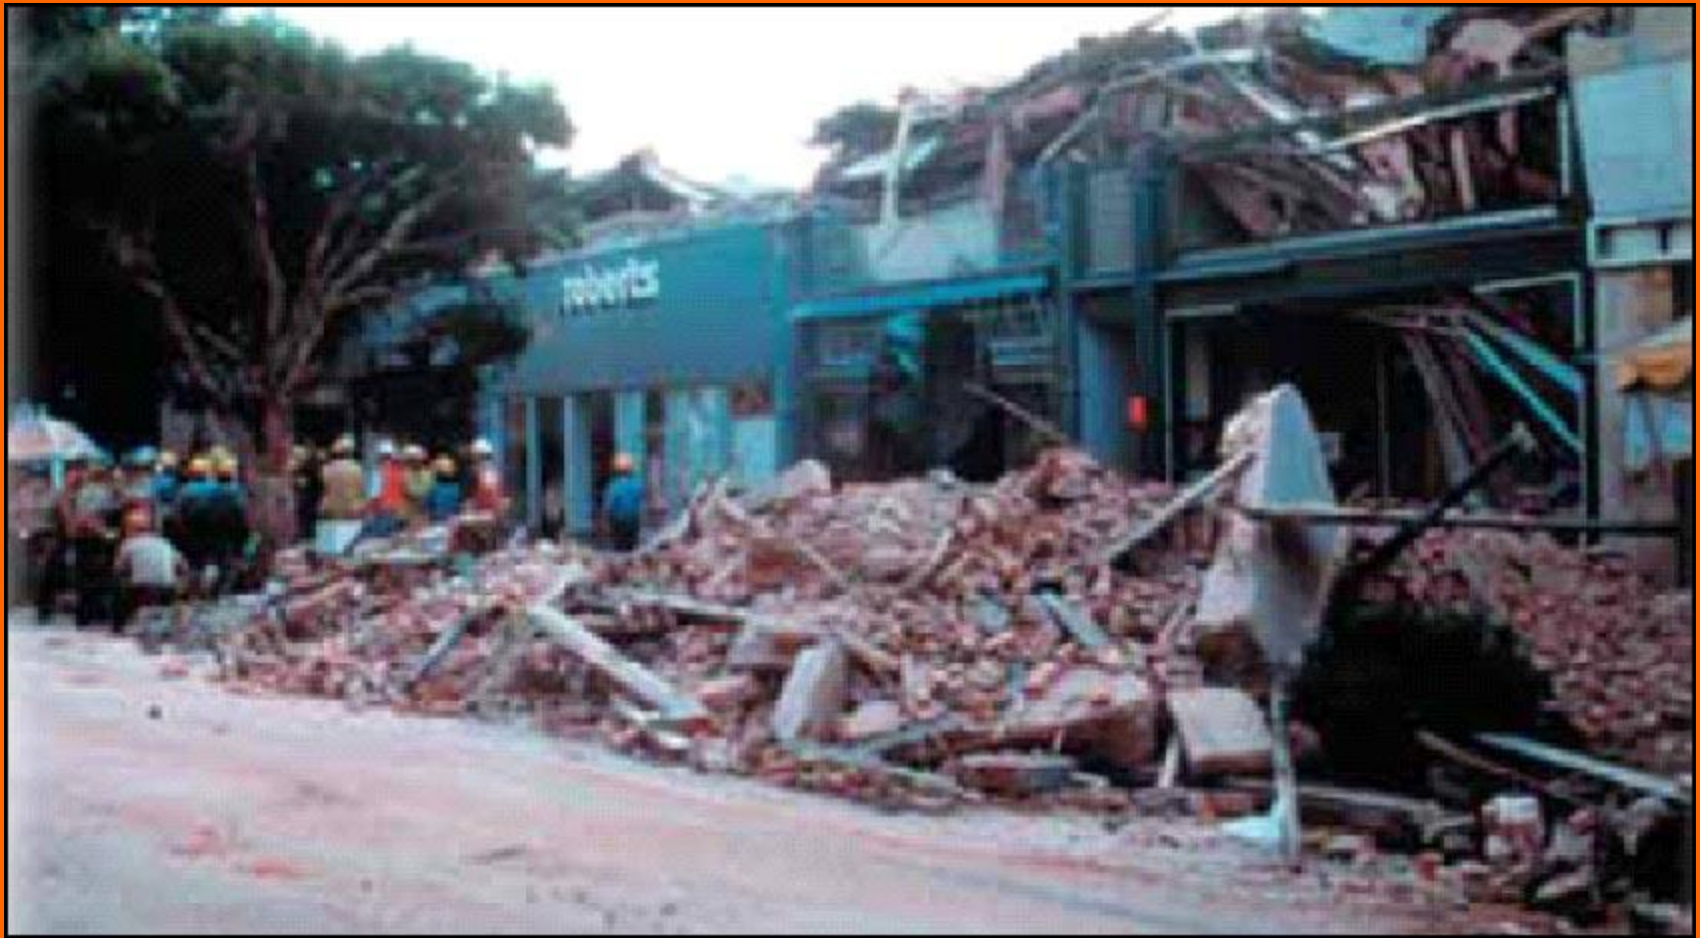
**After the 1989 Loma Prieta earthquake, debris trapped people in buildings and blocked roads in Santa Cruz. After a large earthquake in the Pacific Northwest, it could take days, even months, to reopen freeways and surface streets. Rescue and recovery efforts on the Olympic Peninsula will be effected by damaged infrastructure in the I-5 corridor.**

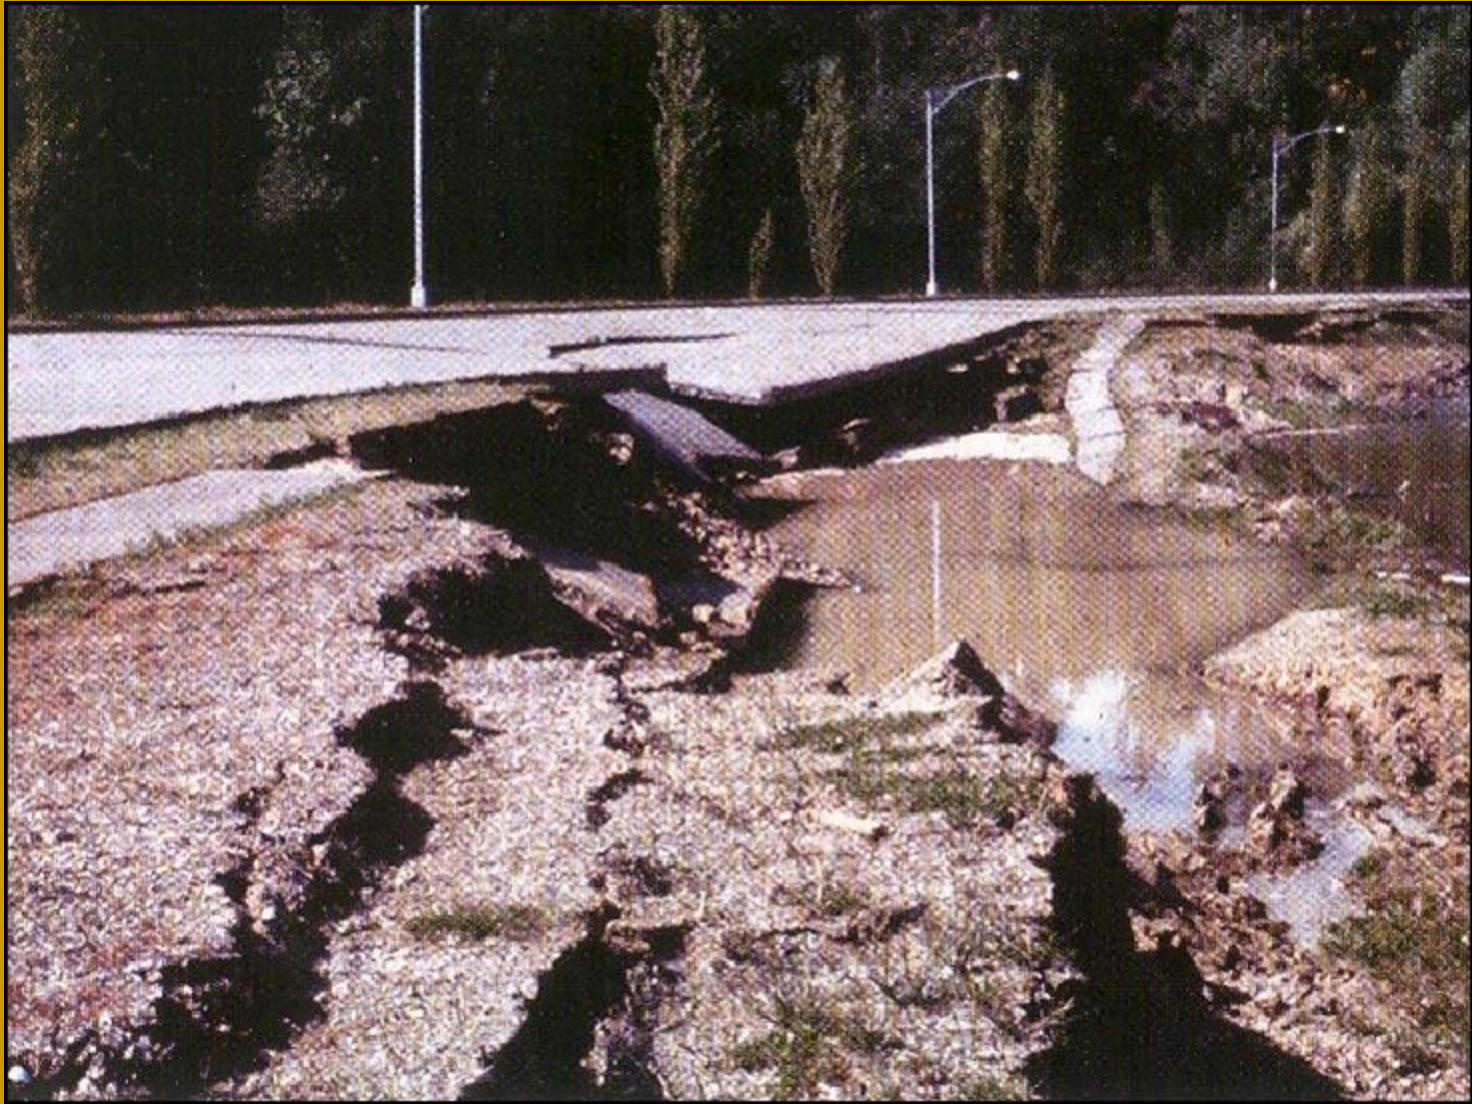
**Liquefaction can destroy roads, as the 2001 Nisqually earthquake did to this street outside Olympia. Many stretches of HWY 101 and other coastal roads in Cascadia are vulnerable to this type of destruction.**

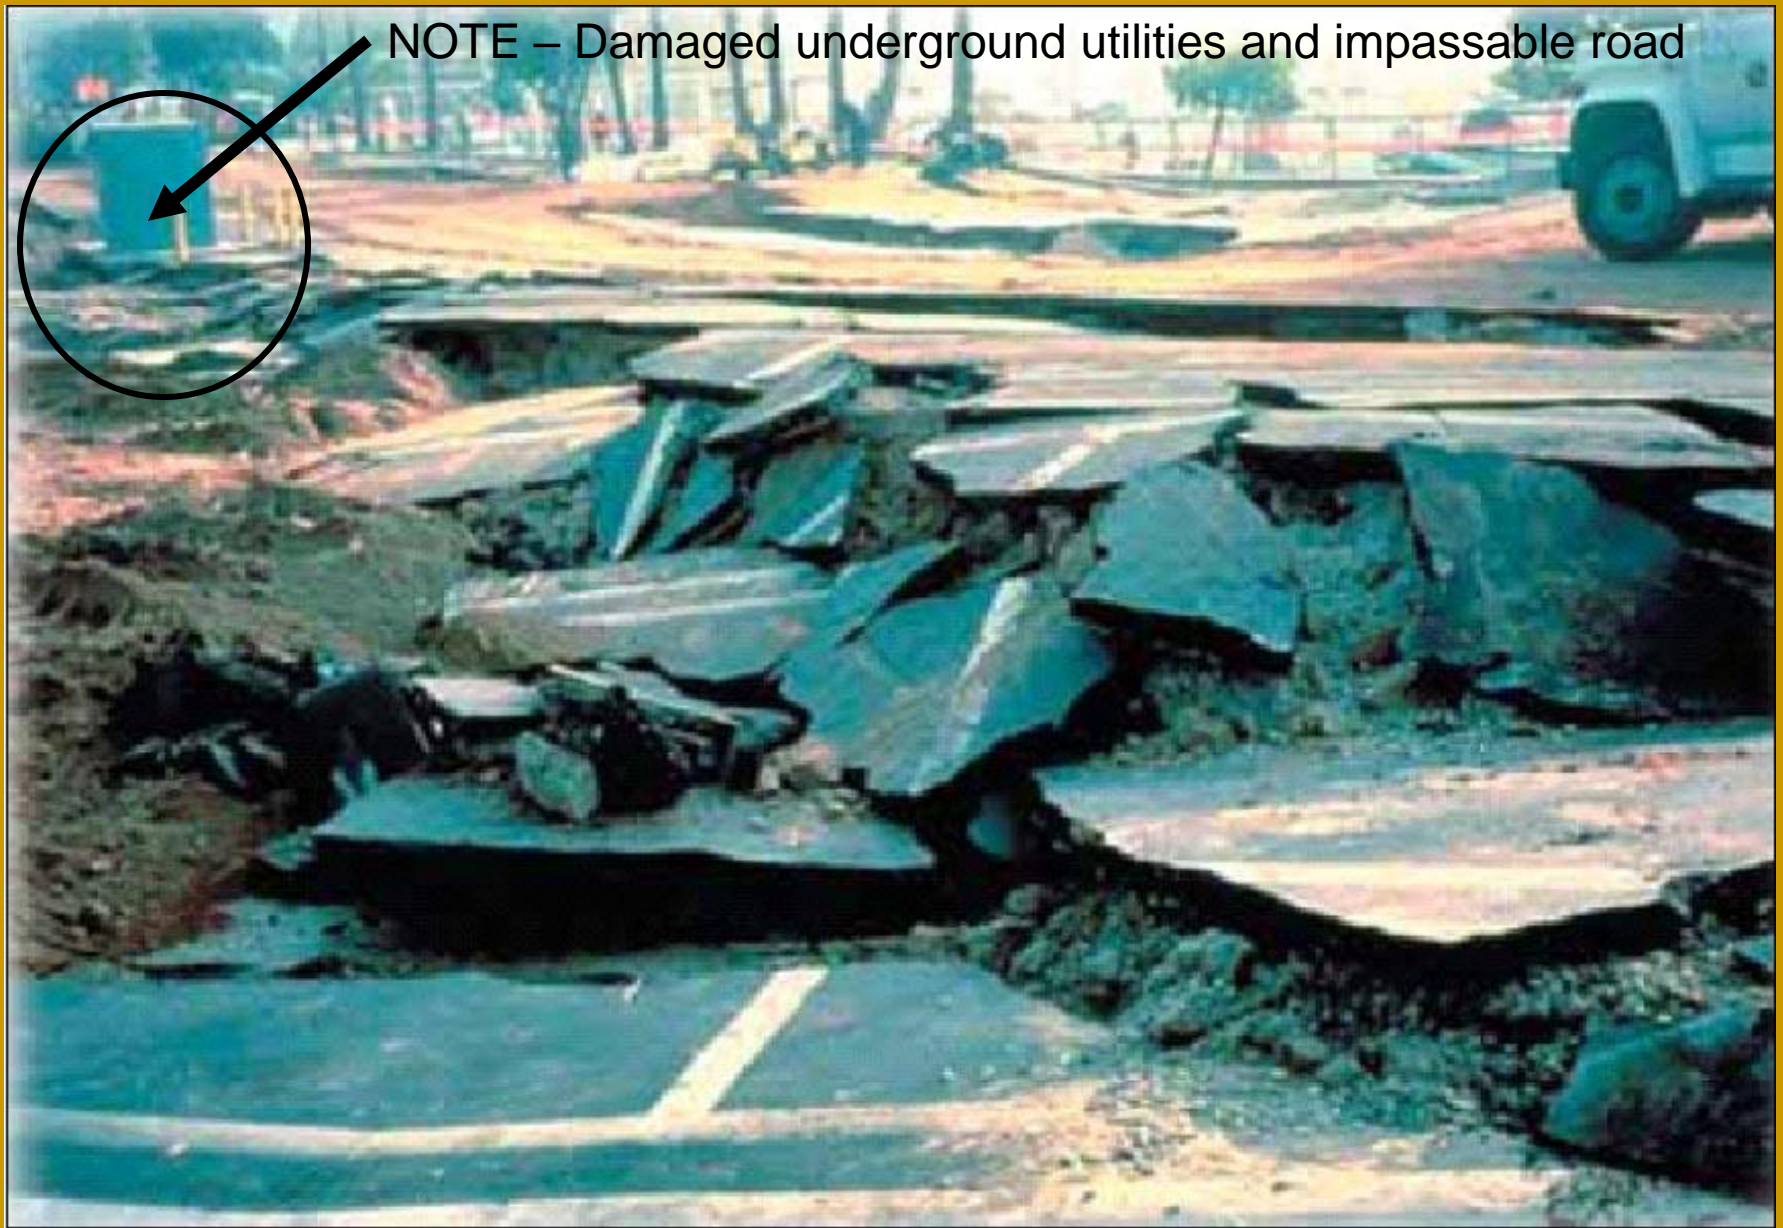
NOTE - Damaged underground utilities and impassable road

**This road was destroyed by liquefaction, when soil beneath the asphalt turned to liquid.**

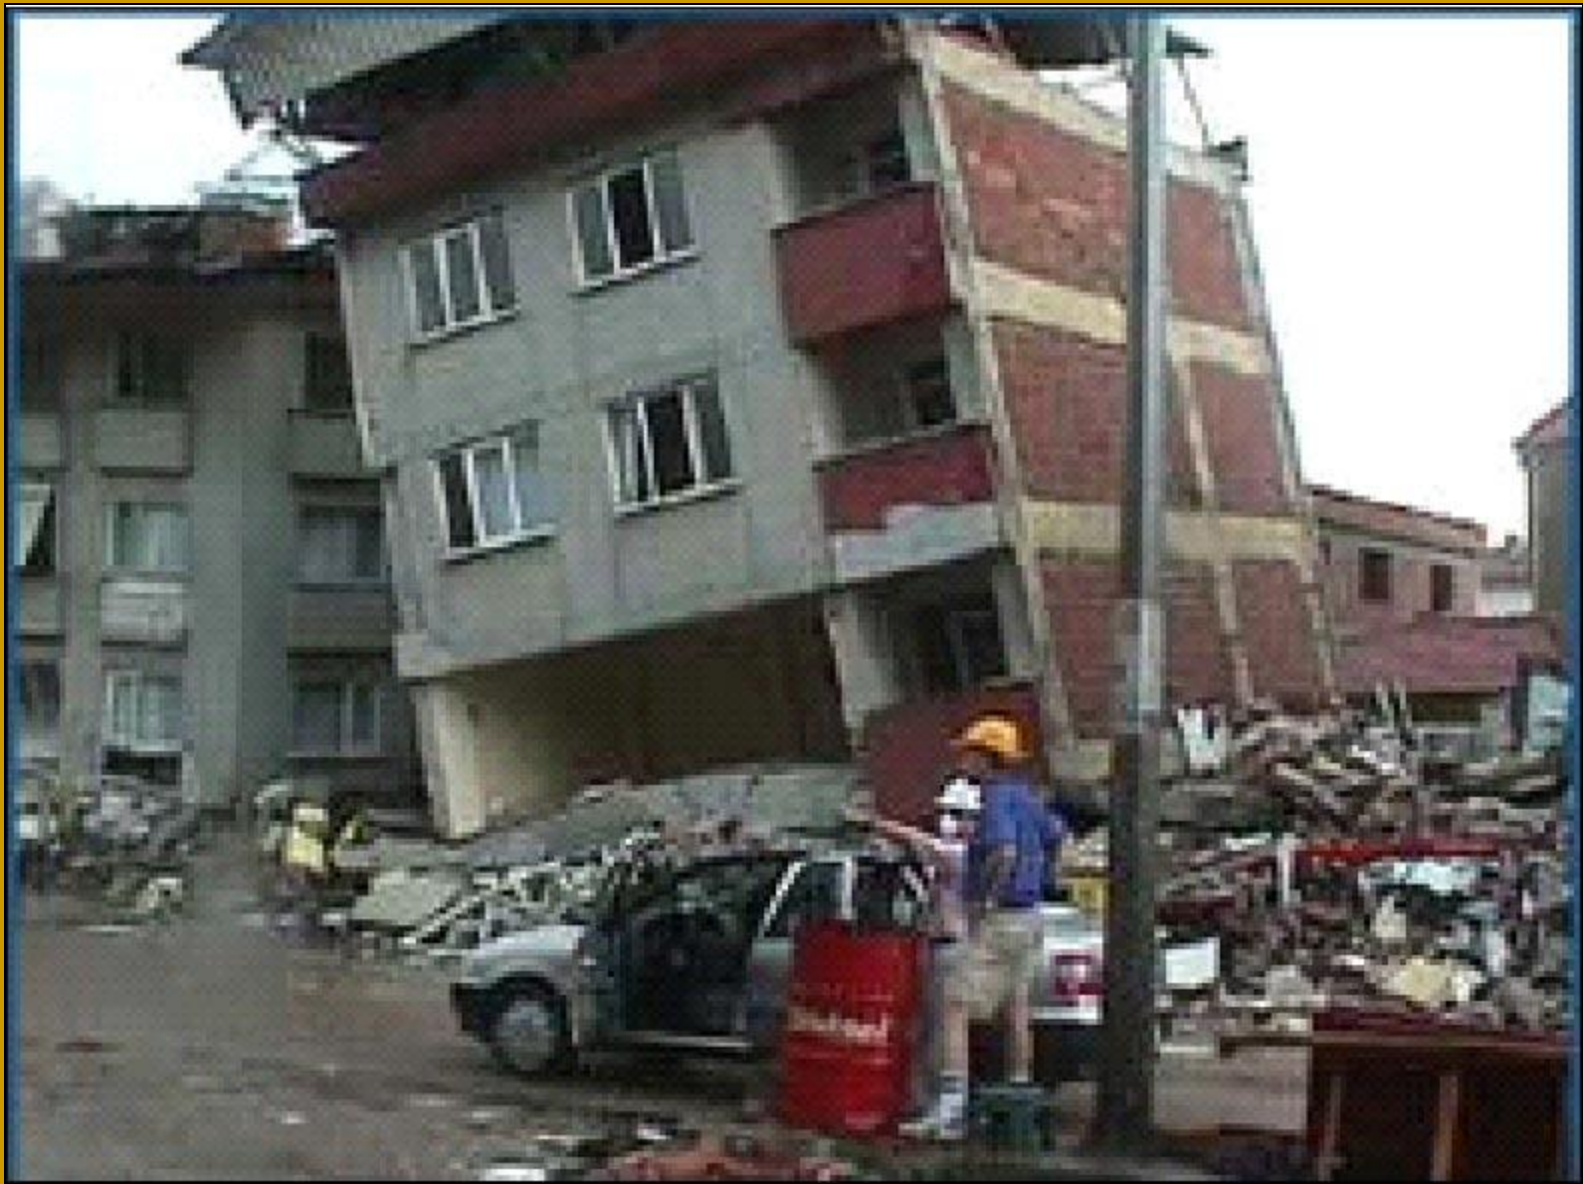
**Foundation failure caused by liquefaction damaged this apartment building. Photo: USGS/Ft. Collins, CO**

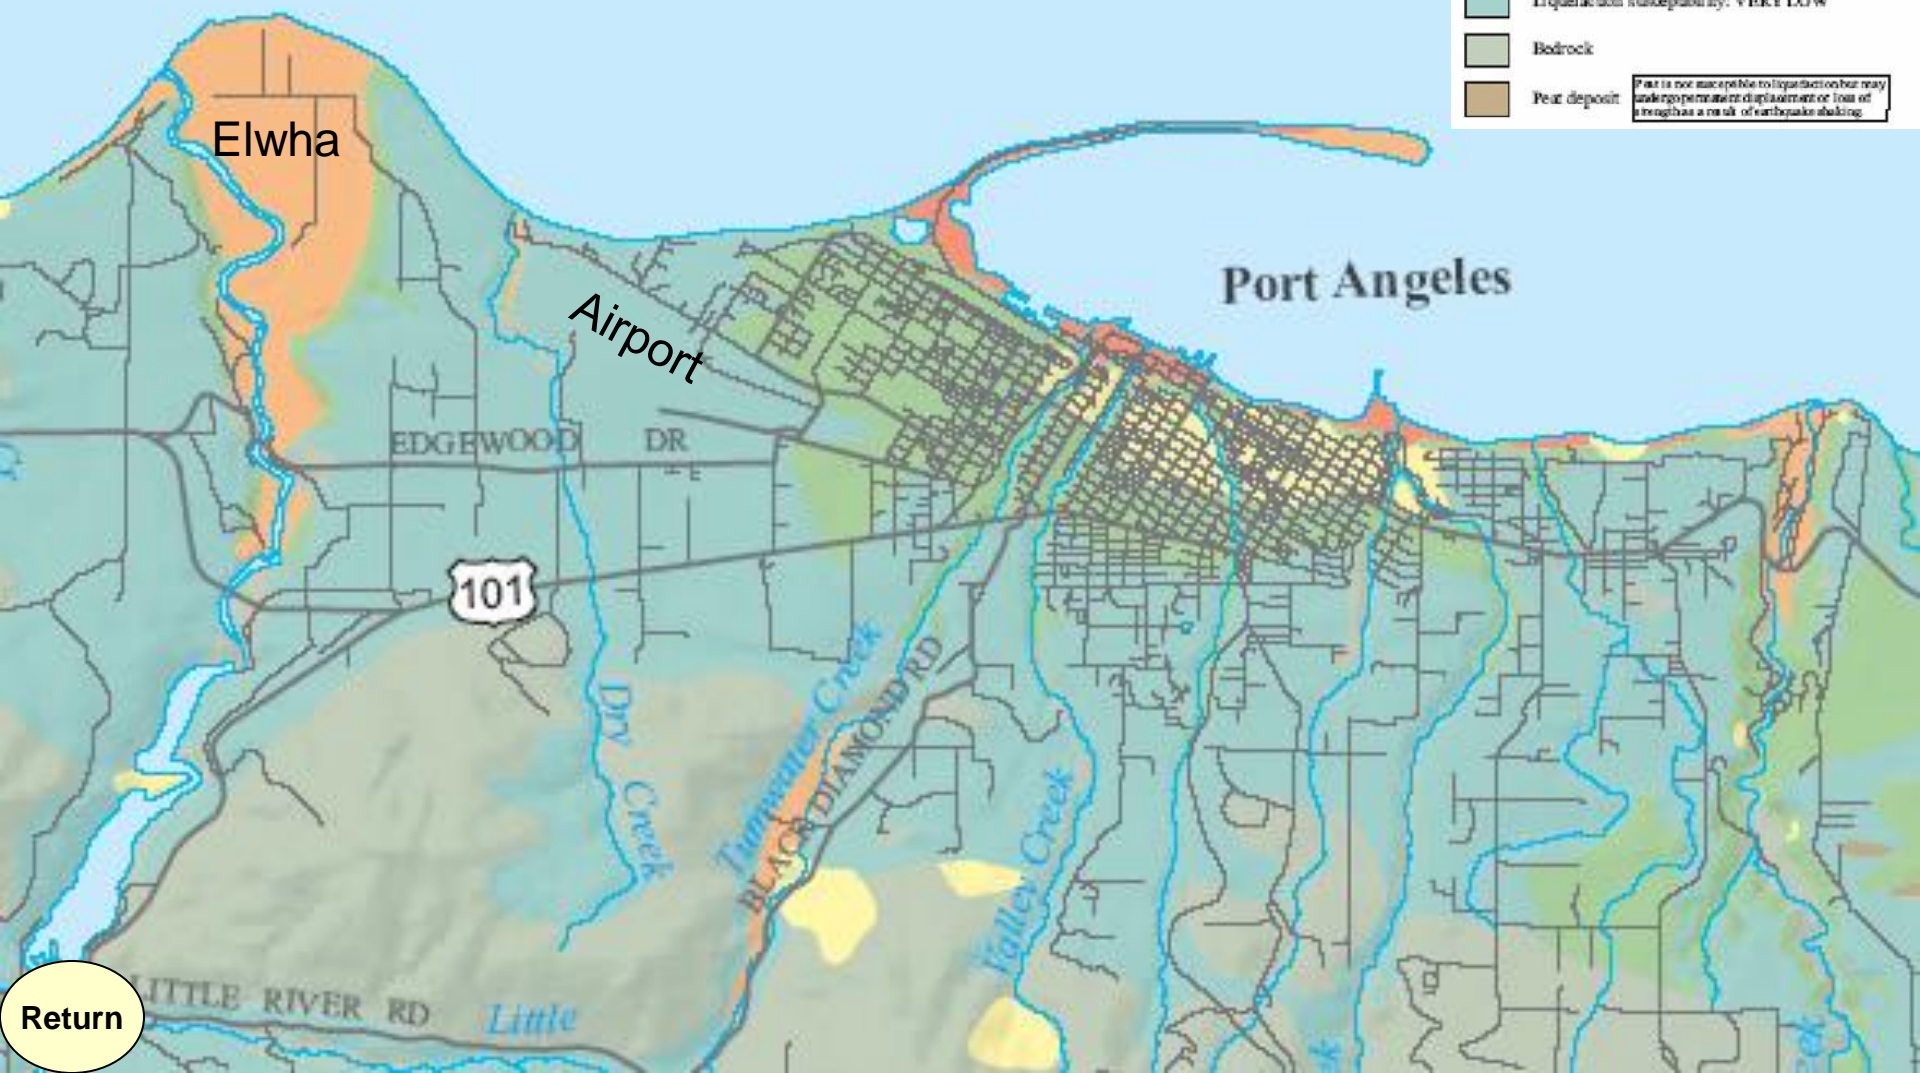
# Liquefaction – PA Vicinity

Peat is not susceptible to liquefaction but may undergo permanent displacement or loss of strength as a result of earthquake shaking.

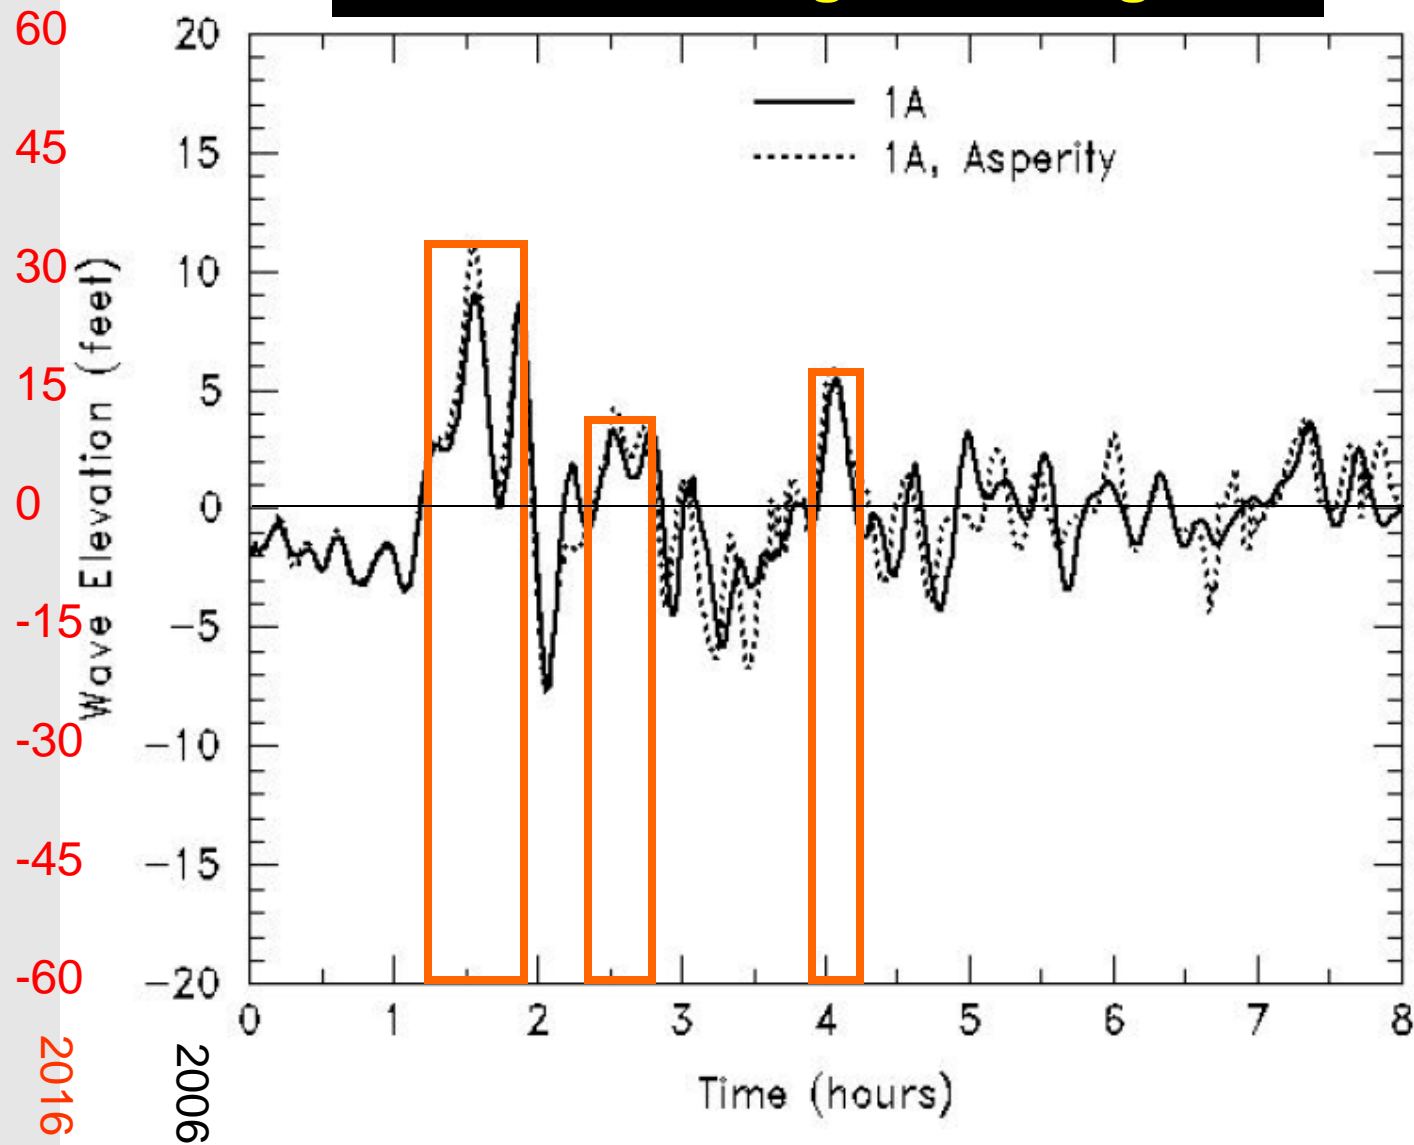
# Tsunami Timing - Port Angeles

Figure 3. Elevation time history of tsunami waves in open water near Ediz Hook. Negative numbers indicate water moving out and positive numbers are water moving in

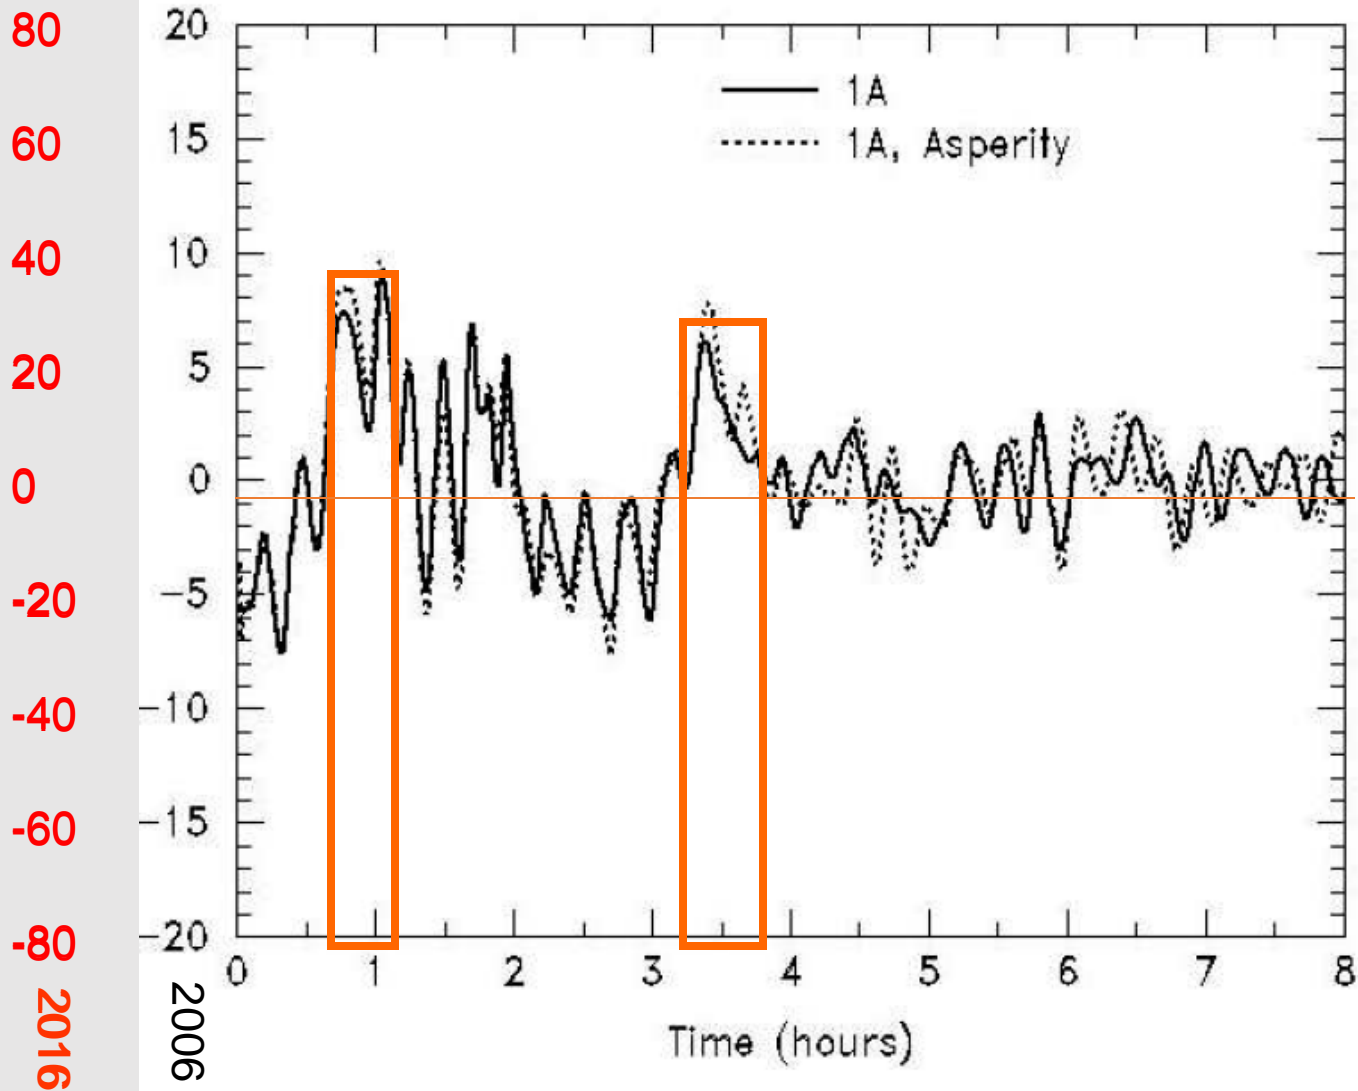
# Tsunami Timing - Neah Bay

Figure 3. Elevation time history of tsunami waves in open water near Neah Bay. Negative numbers indicate water moving out and positive numbers indicate water moving in.

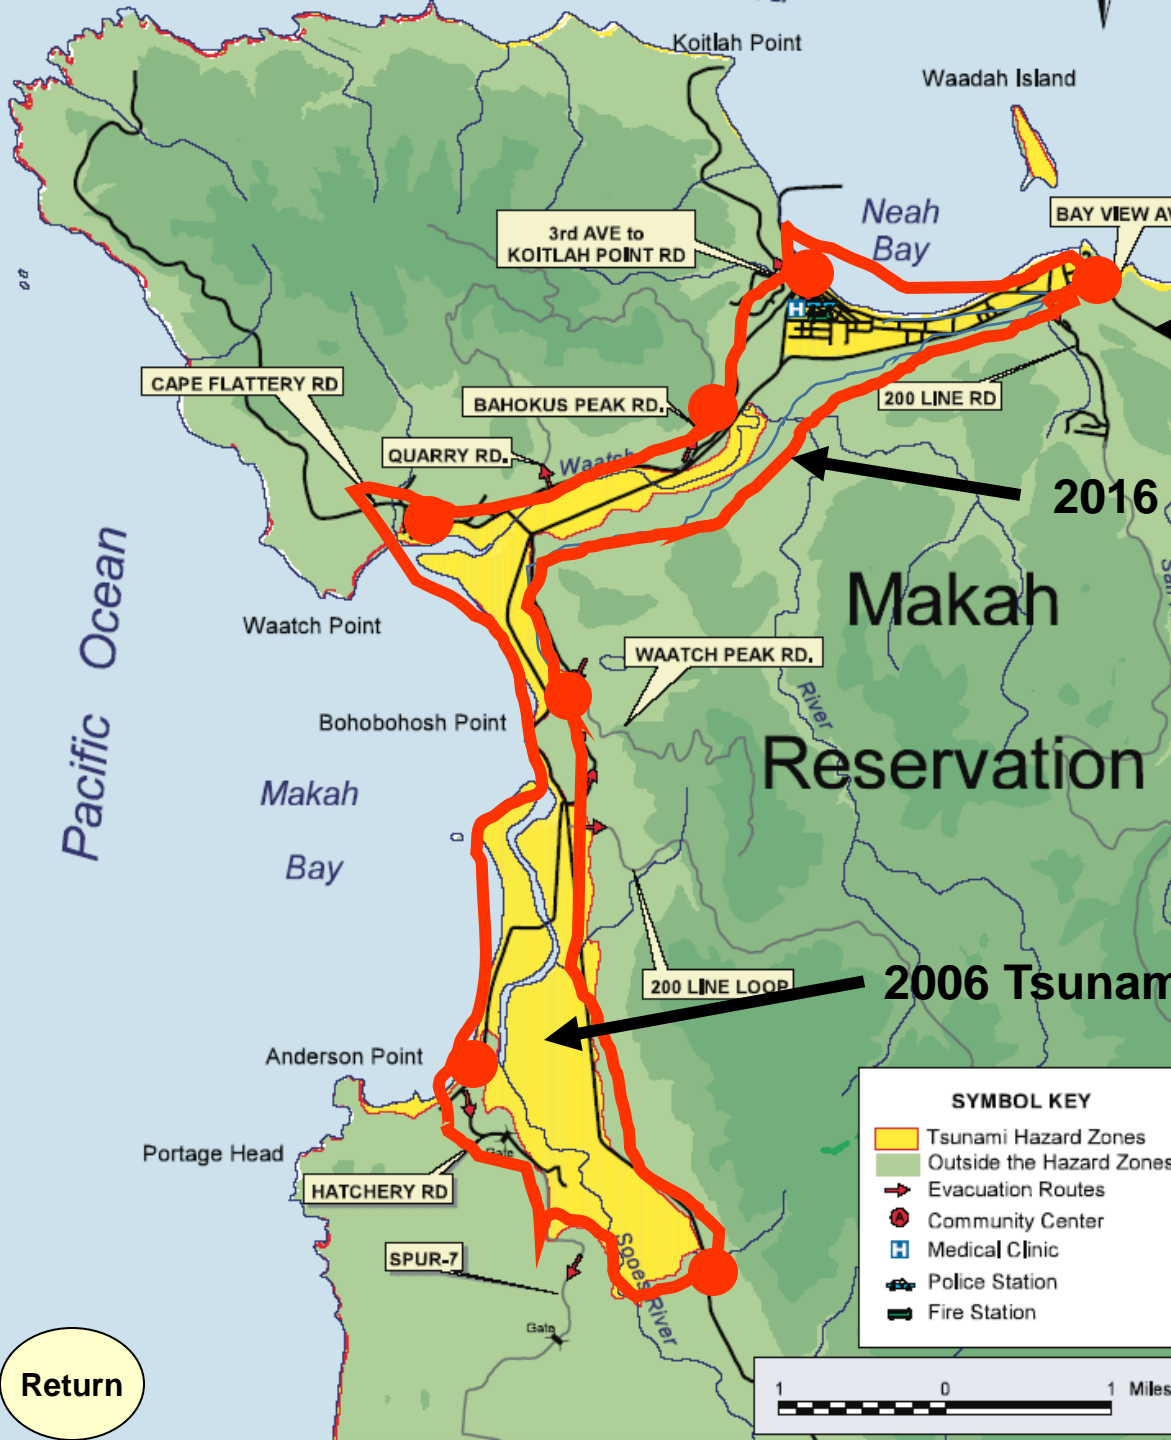
# Summary of Damage Near Bay

2016 Tsunami Scenario

2006 Tsunami Scenario

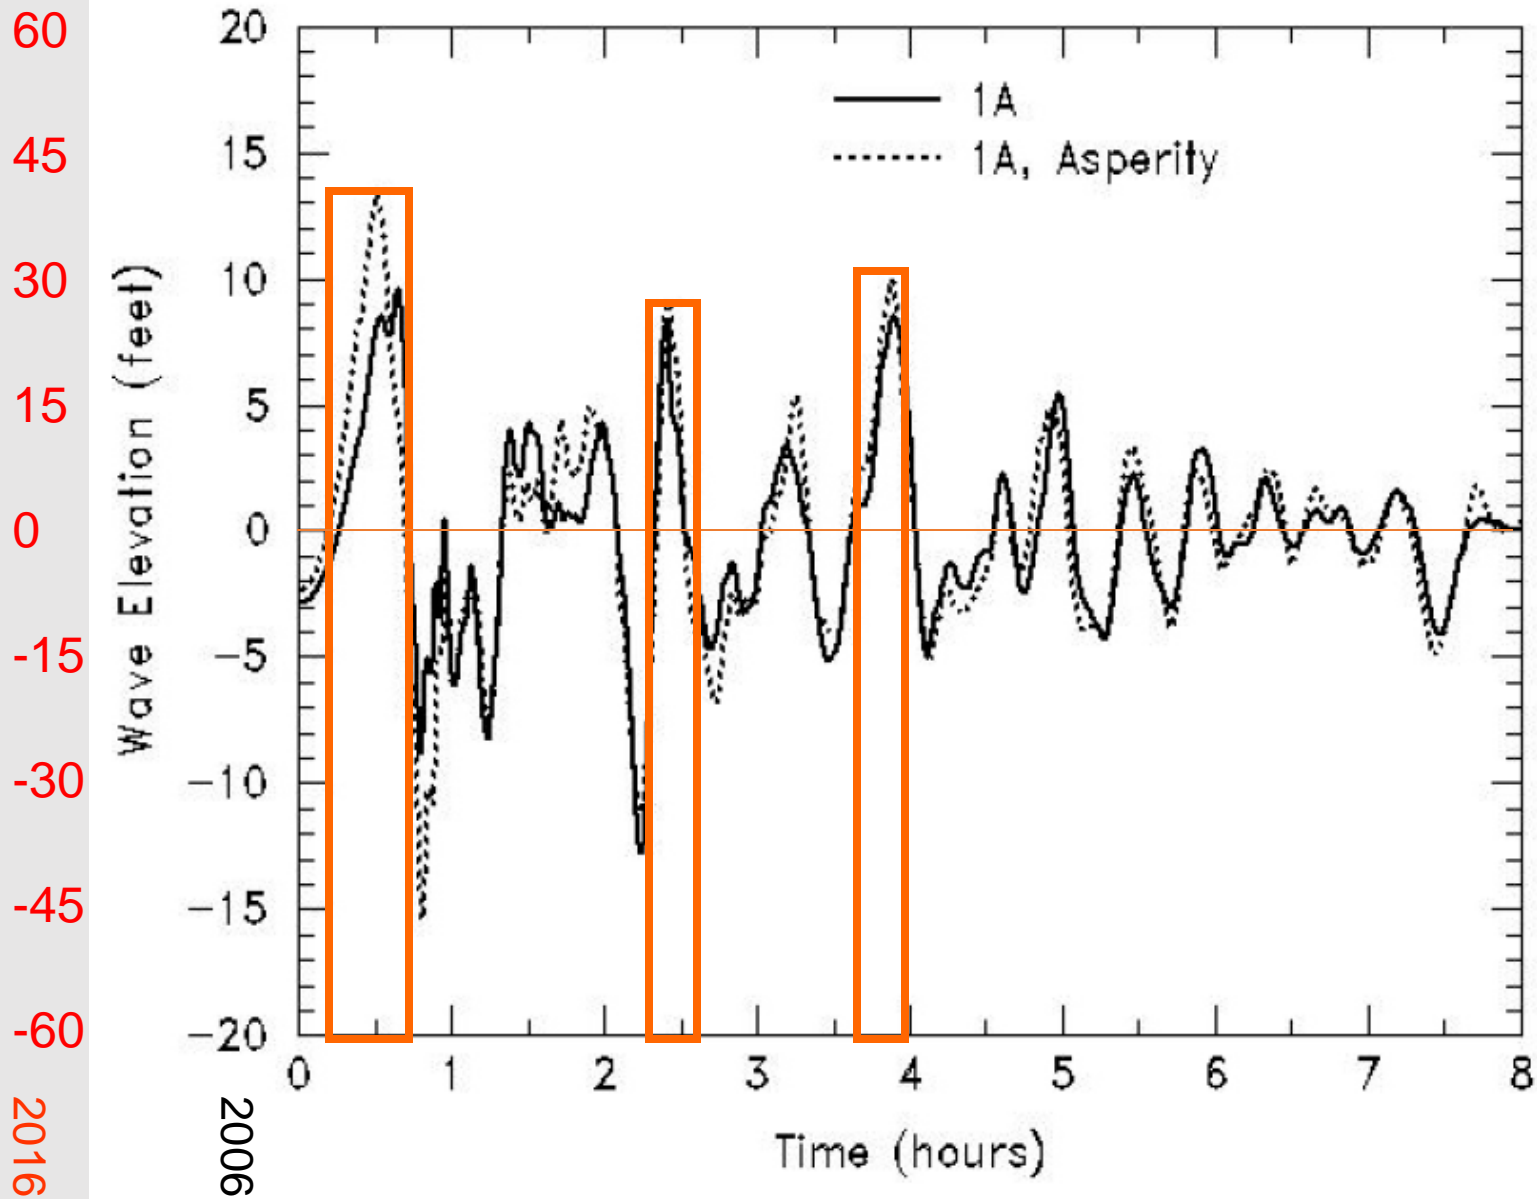
# Tsunami Timing - La Push

**Figure 3.** Elevation time history of tsunami waves in open water off the Quileute Reservation. Negative numbers indicate water moving out and positive numbers

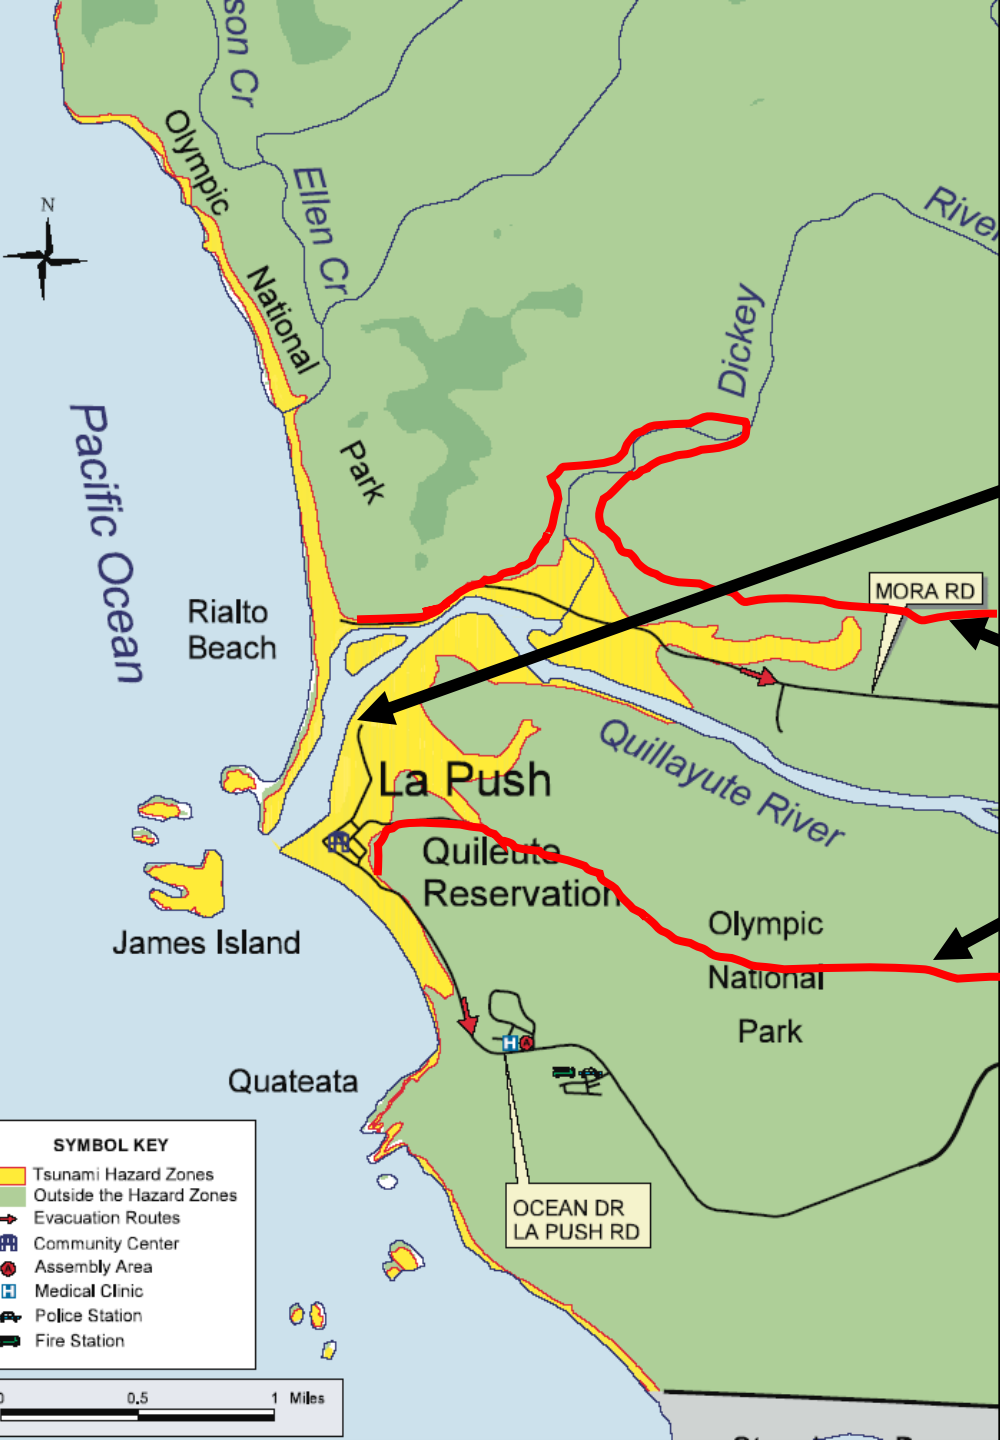
# Evacuation routes for La Push

2006 14' Tsunami

2016 31' Tsunami with 6' subsidence
